THERMAL IMAGING INSPECTION AGREEMENT

Cost: _____ Address: 1234 Lagos De Campo Blvd. City / Zip: Tamarac, 33321

HOME INSPECTION REPORT

Report Number: 161157
Date: 9/23/2016

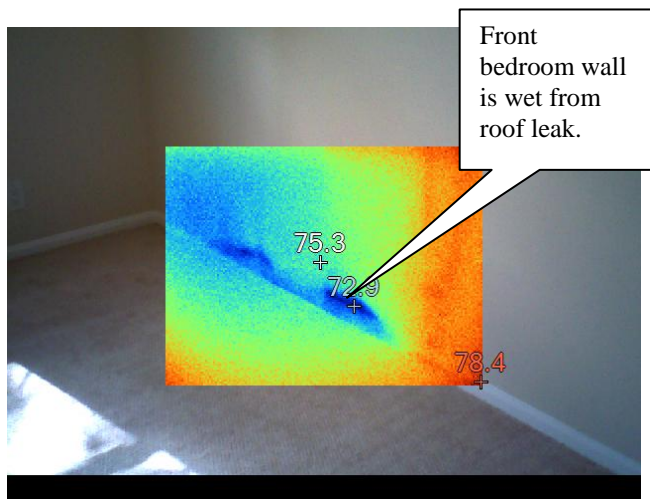
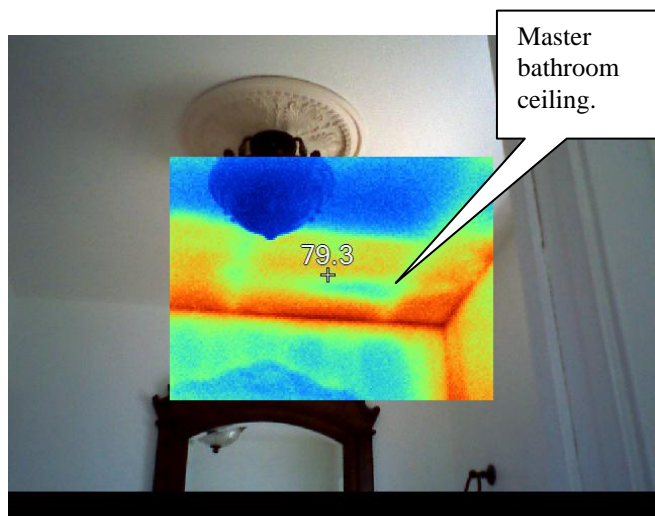
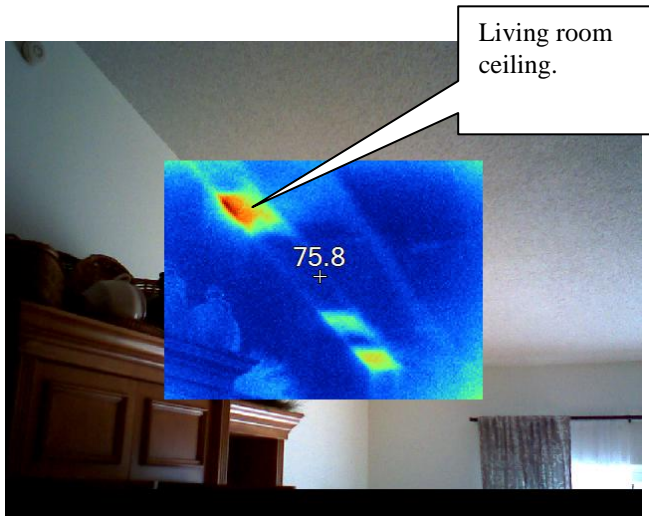
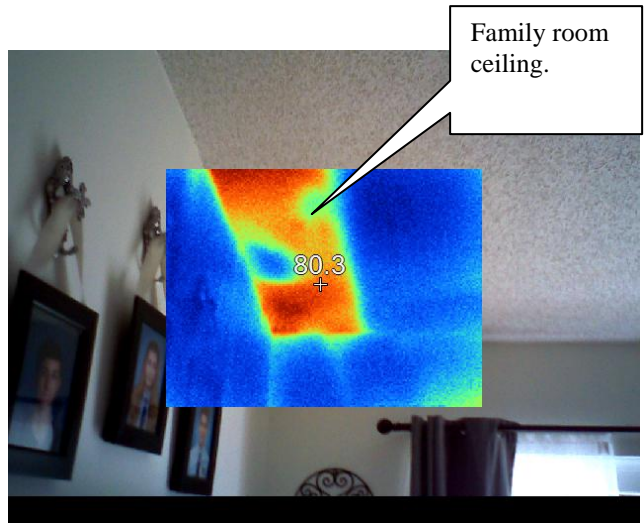
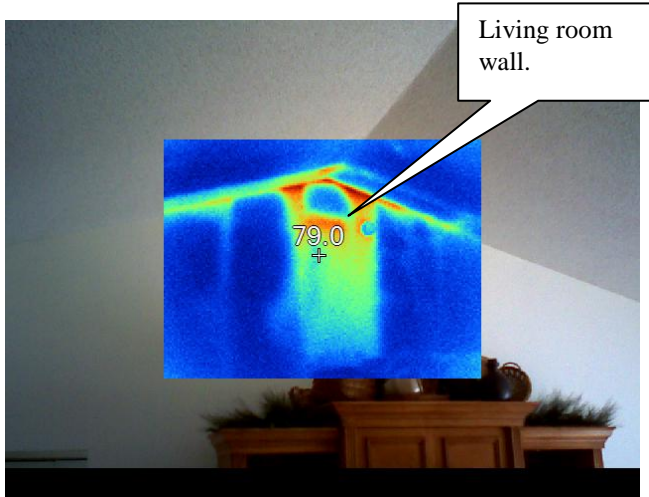
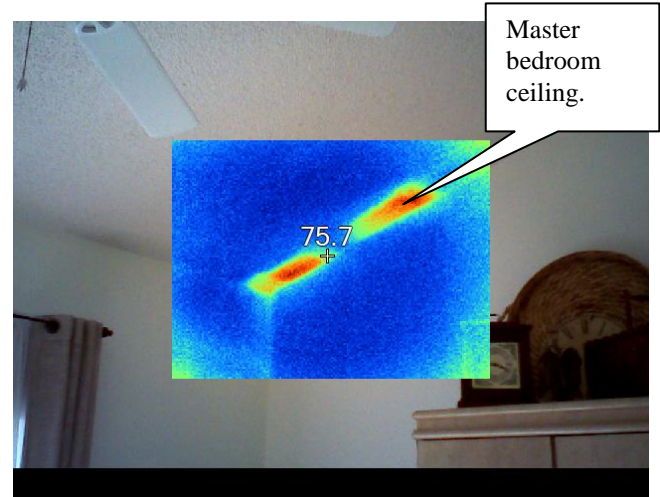
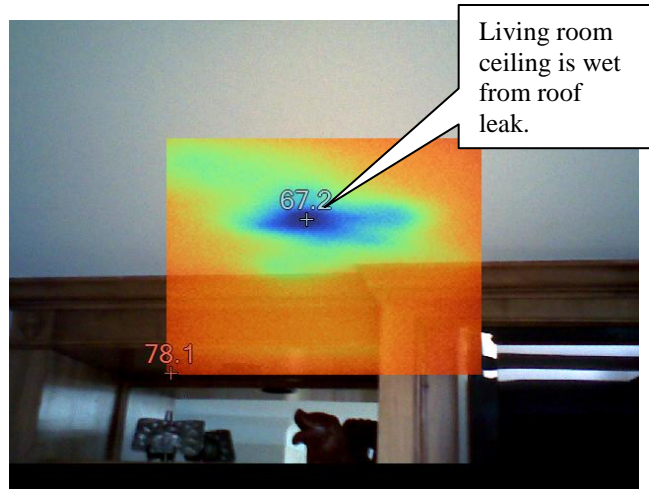
- 2. The front bedroom wall is wet at the bottom, this appears to be from an active roof leak.
- 2. Attic insulation is missing at the living room peak and hot air is being transferred into the wall in this area.
- 4. Insulation is missing from the ceiling in the master bathroom above the mirror, family room above the glass door in rear, living room near the ceiling peak, master bedroom right side.
- 4. The living room ceiling is wet from an active roof leak.

1. Several areas of attic insulation are missing and attic heat is being transferred to the inside living space (ceiling), see "Interior Rooms" page for details.

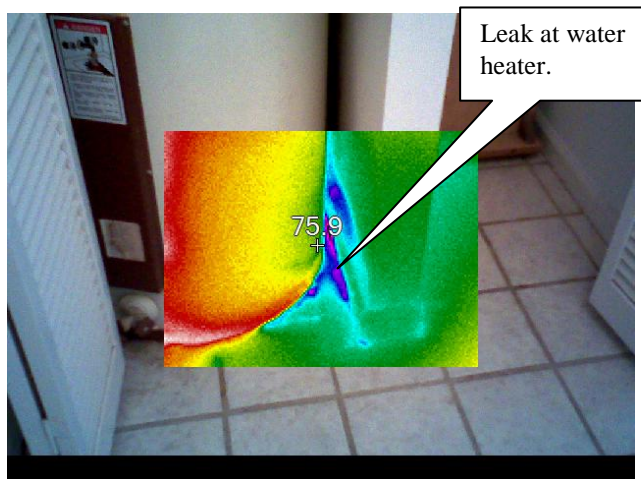
10. The water heater is leaking at the bottom and the surrounding wall is wet.

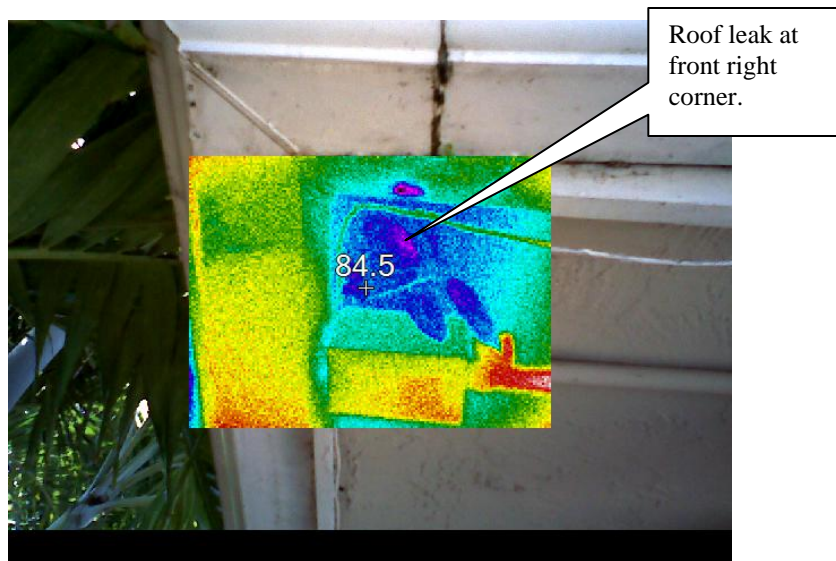
7. The front right corner of the roof is leaking into the fascia.
