Cost: _____ Address: 123 Wood Drive City / Zip: Boca Raton, 33499

HOME INSPECTION REPORT

Report Number: 161130
Date: 7/11/2016

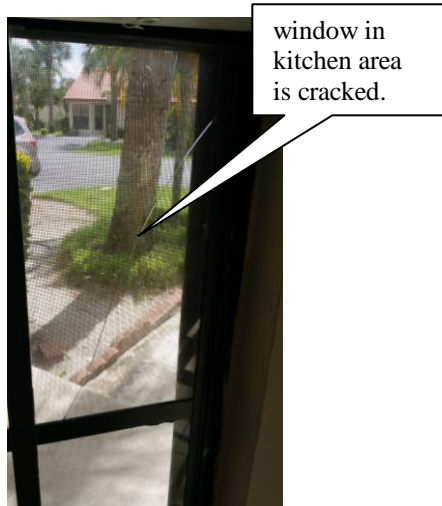
7. One window in the kitchen eating area is cracked.

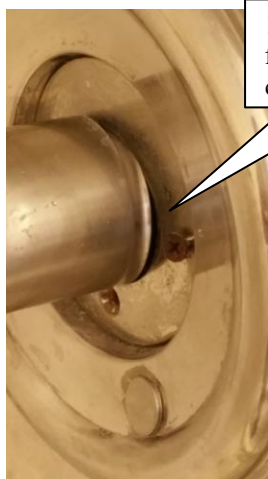
4. The 1st floor shower faucet rotational stop is damaged and the faucet is poorly mounted and allowing water into the wall.

1st floor shower faucet not mounted correctly.

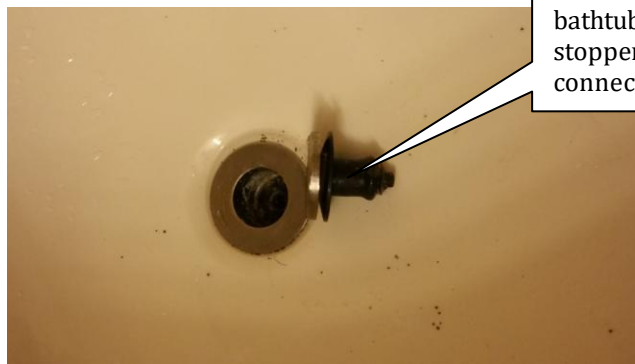
bathtub water stopper is not connected

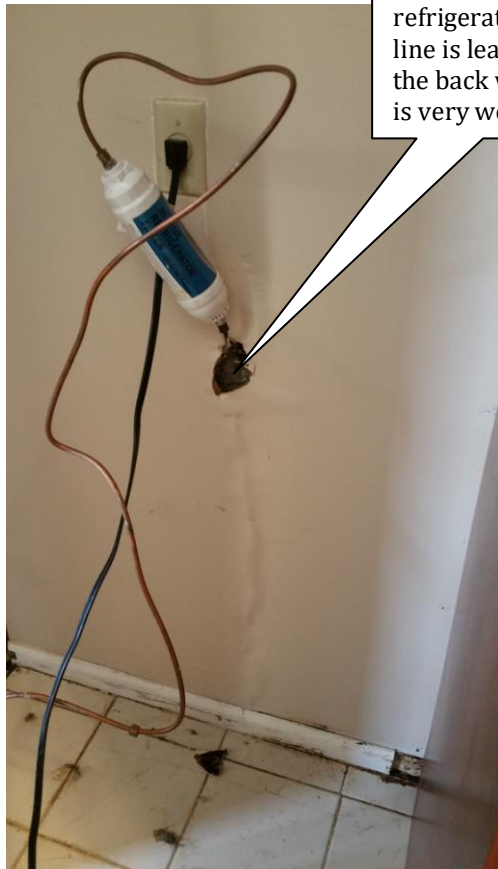
12. The water supply line for the ice making is leaking into the wall; the wall is very soft and has what appears to be mold present, this will need to be further looked at and tested.

refrigerator water line is leaking into the back wall, area is very wet and soft

- 1. The bottom of the wall in the kitchen eating area is measuring over 40% moisture; this is coming from an active leak in the refrigerator water supply line.
- 9. Both smoke detectors are not working and will need to be replaced right away.

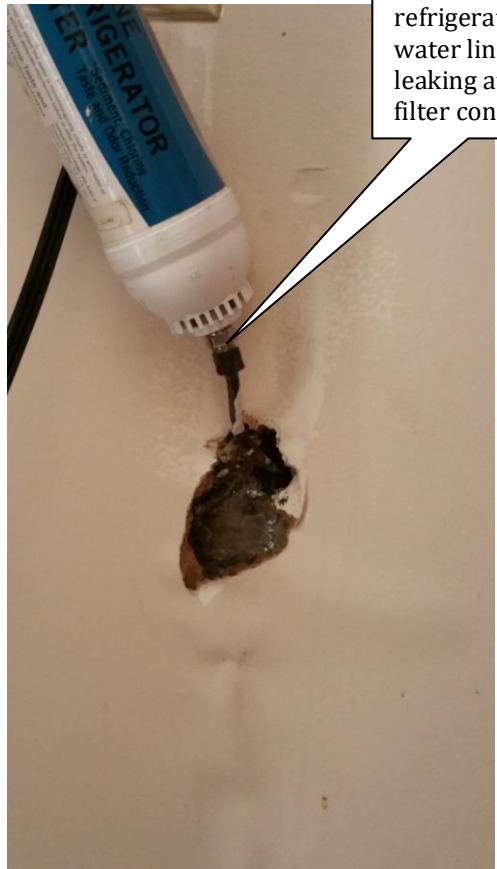
refrigerator water line is leaking at the filter connection

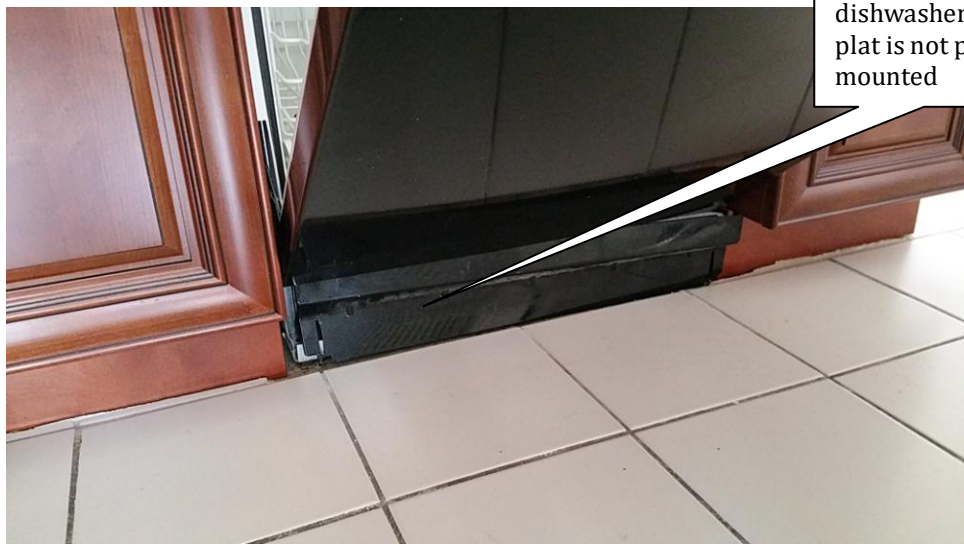
13. The dishwasher kick-plate is not fastened properly and is hitting the lower portion of the door when opened.

dishwasher kick plat is not properly mounted

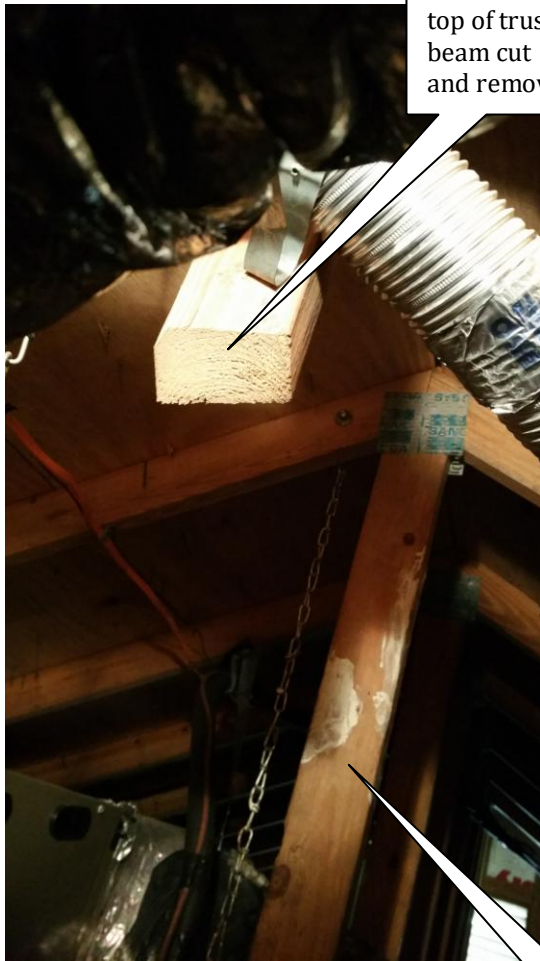
Note: One truss beam has been cut and removed; it appears this was done during the air conditioner replacement, repair is needed.

top of truss beam cut and removed

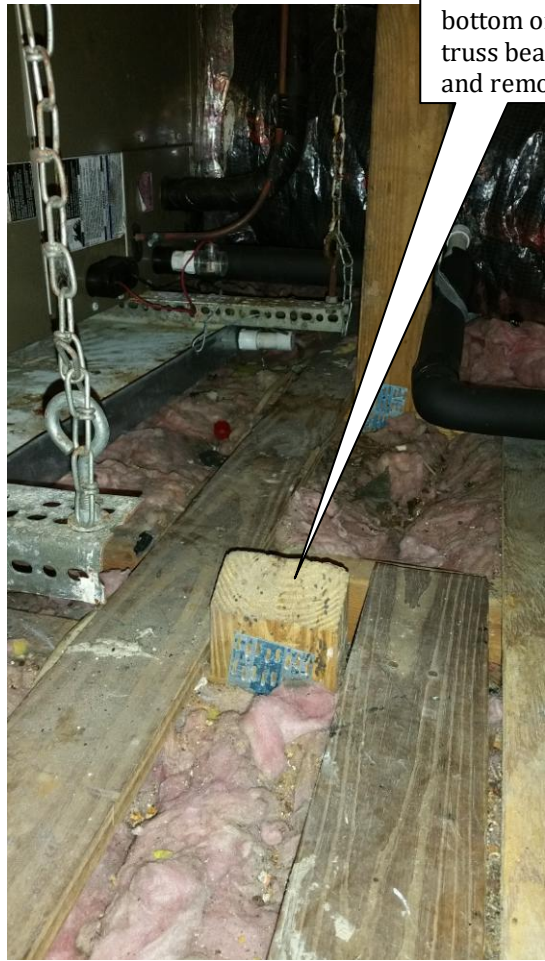
bottom of truss beam cut and removed

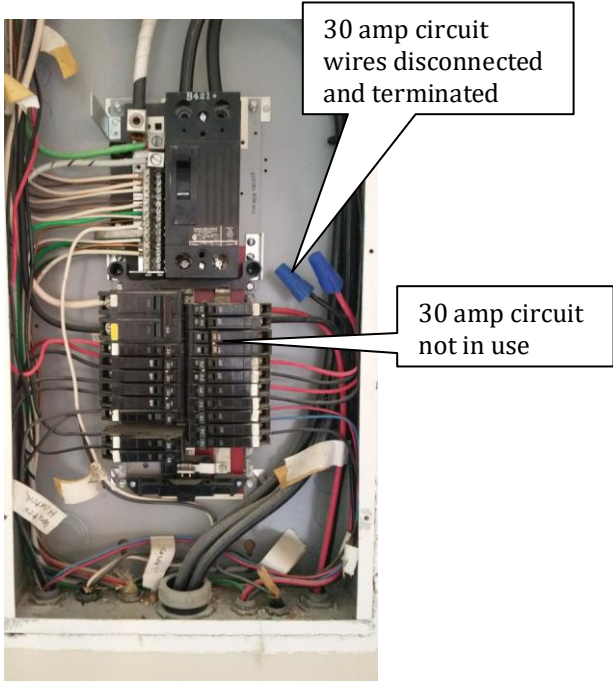
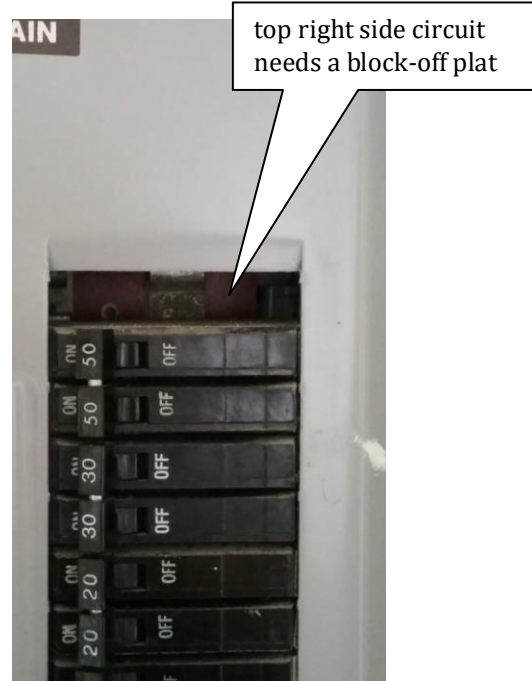
Note: One circuit slot is missing a block-off plate.

Note: The 30 amp circuit breaker on the right side has been disconnected and currently not being used.
